BTA Foils 2003

C.J. Gardner

November 7, 2003

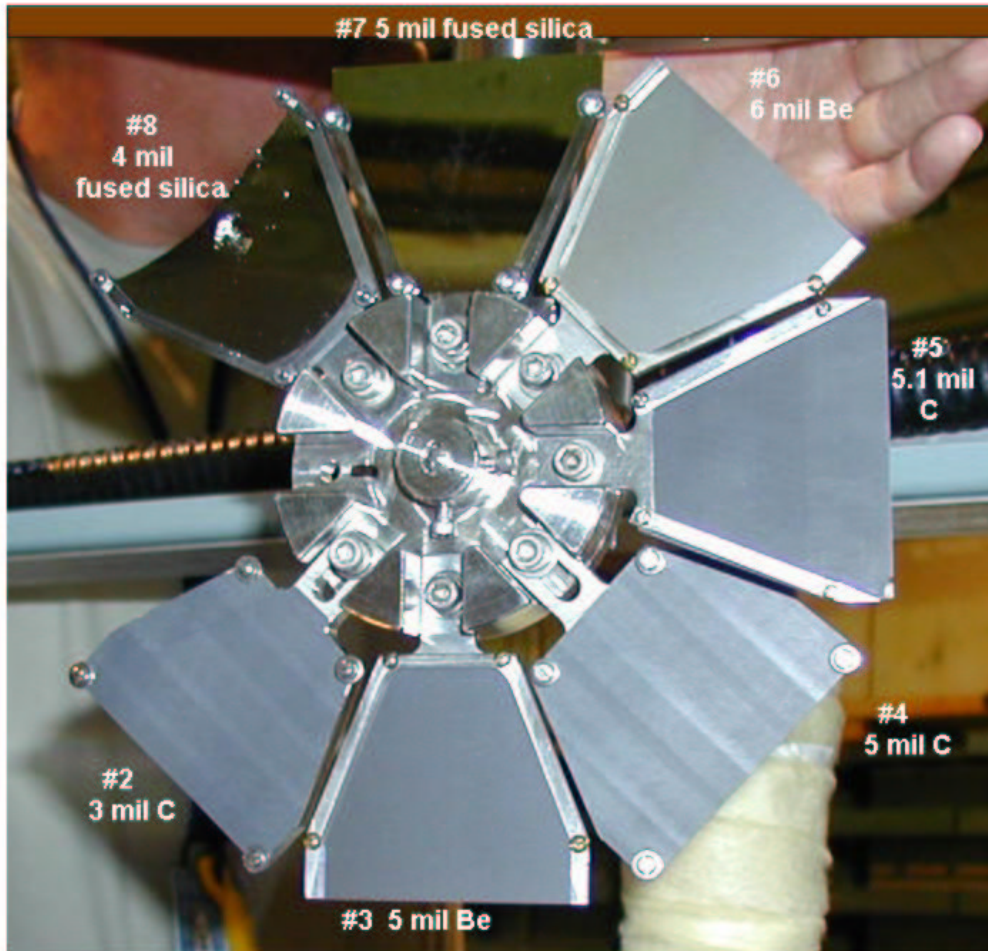
2003. Note that the silica foil in holder 8 has acquired a bump which protrudes in the downstream beam direction.

Figure 2: BTA Foils after new ones were mounted in September 2003. The beam direction here is into the picture. Holder 2 is just below the empty slot. Holders 3 through 8 follow consecutively going counter-clockwise from Holder 2. Note that the silica foil in holder 8 has acquired a bump which protrudes in the downstream beam direction.

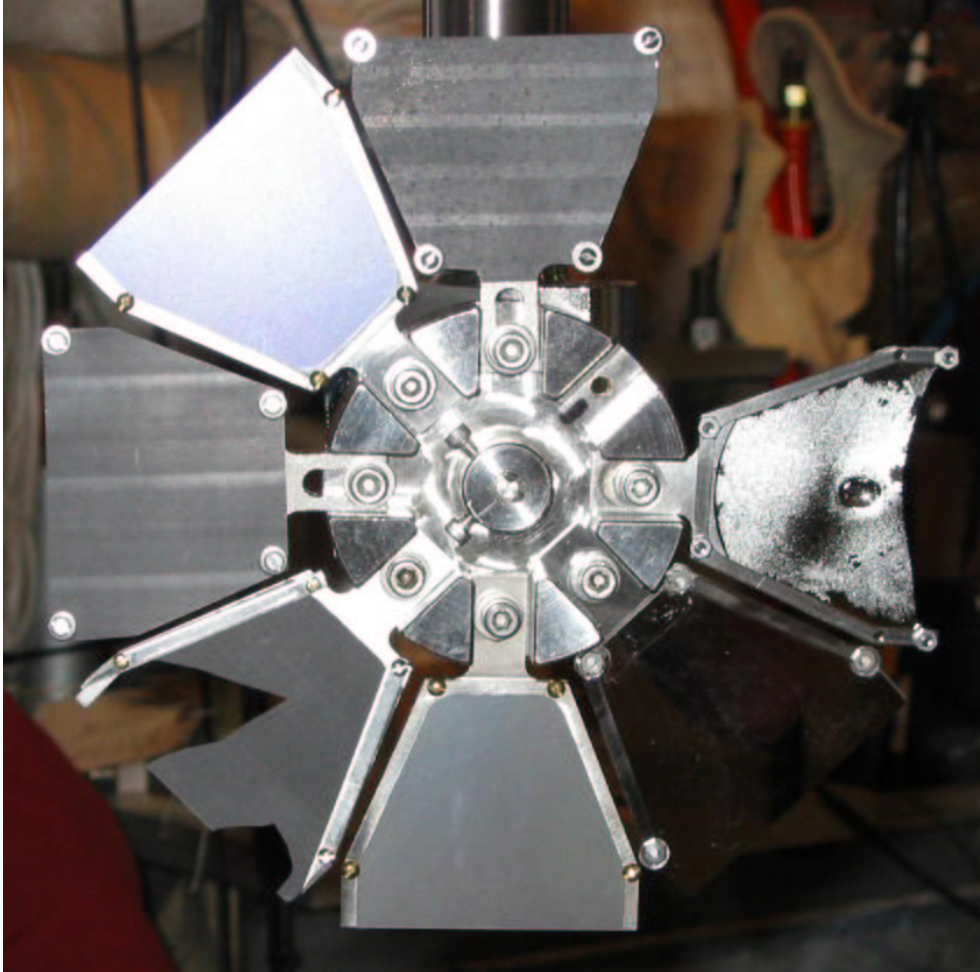
Around 30 October 2003 it was discovered that BTA foils 5 and 6 could not be rotated into position. Upon opening up the BTA spool piece on 3 November it was found that a screw protruding from one of the holders was stopping the rotation of the assembly. **Figure 3** shows the foils just after they were taken out of the spool piece. The carbon foil in Holder 5 is clearly broken. This may have happened as the assembly was being lifted out of the spool piece. Although it can not be seen in the photograph, the carbon foil in Holder 2 has a long crack. The raised bump visible on the silica foil in Holder 8 protrudes in the downstream beam direction.

Figure 3: BTA Foils just after they were taken out of the BTA spool piece on 3 November 2003. The beam direction here is into the picture. Holder 2 is just to the left of the empty slot. Holders 3 through 8 follow consecutively going counter-clockwise from Holder 2. The carbon foil in Holder 5 is broken, and, although it can not be seen here, the carbon foil in Holder 2 has a long crack. The raised bump on the silica foil in Holder 8 protrudes in the downstream beam direction.

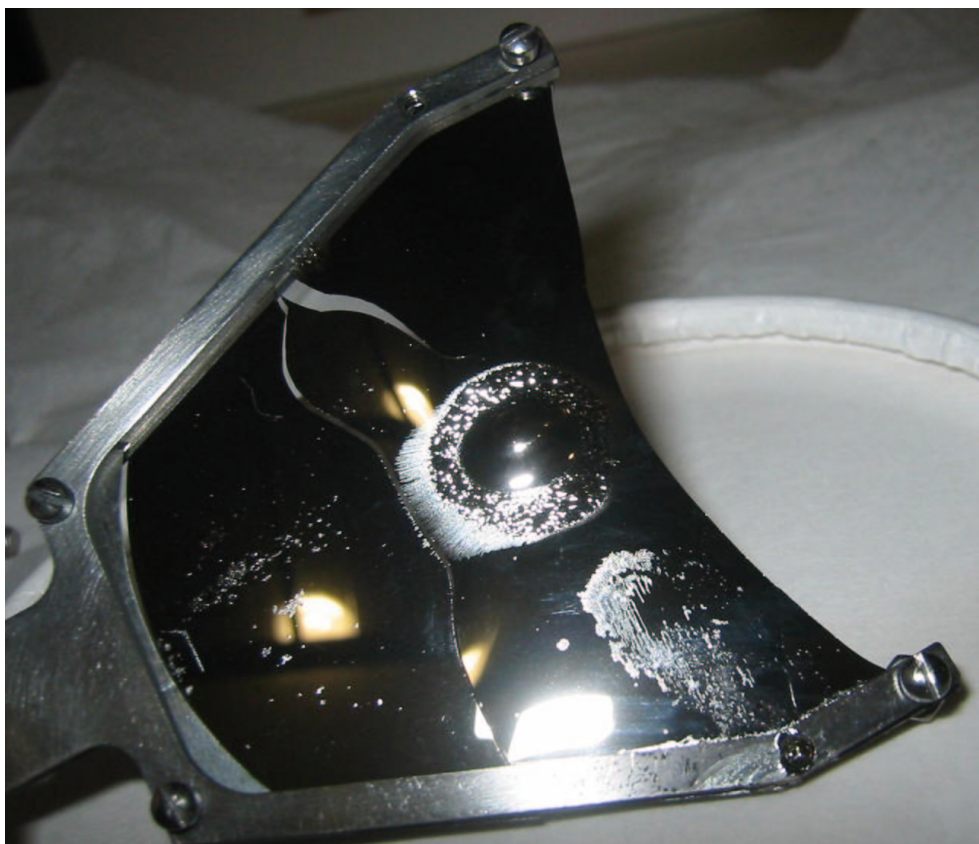
Figure 4 shows a close-up of the bump. Note the area of crystallization around the bump. Note also that the foil has several long cracks. These were not visible until the day after the foils were taken out of the BTA spool piece. One thought is that the thin carbon coating on the foil was holding the cracked pieces together until exposure to air or vibration caused the cracks to be uncovered.

Figure 4: Close-up of the bump on the silica foil in holder 8. Note the area of crystallization around the bump. Note also that the foil has several long cracks. These were not visible until the day after the foils were taken out of the BTA spool piece. One thought is that the thin carbon coating on the foil was holding the cracked pieces together until exposure to air or vibration caused the cracks to be uncovered.
